# Manhole Inspection Summary

Manhole # S15II\_016MH

Insp Date: **2/20/09 10:28 AM**

**Location** Address: **REAR 1733 THOMAS**

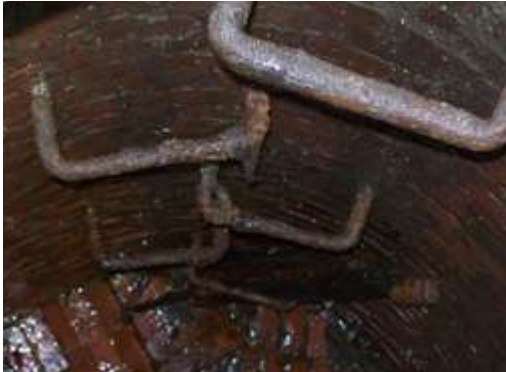
Defect 1

**Surcharge** ☒ **Evidence Of Surcharge** Depth: **2** (ft.) ☐ Active Surcharge Present

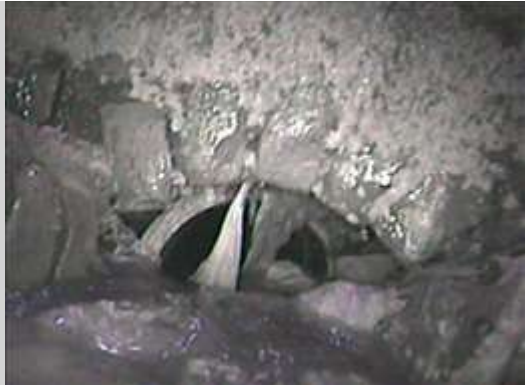
12 O'Clock Outflow

8 in. Circular Gravity Sewer  
Pipe Out @ 12 O'Clock

Pipe Height: **3.6** (in.) Rod and Bar  
Pipe Material: **Clay** ☐ Pipe Lined  
Invert Depth: **10.59** (ft.) Flow Characteristics: **Slow**  
Deposits: ☐ None ☐ Mud ☒ Sludge ☒ Debris ☐ Grease  
Silt Depth: **2** (in.) Deposits Extent: **Medium**  
Infiltration: **None** Pipe Seal Cond: **Cracked**

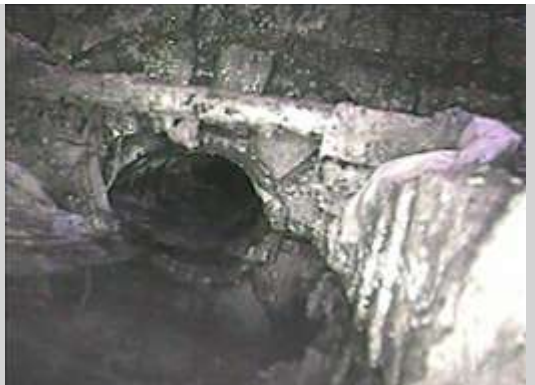
3 O'Clock Inflow

8 in. Circular Gravity Sewer  
Pipe In @ 3 O'Clock

Pipe Height: **4.8** (in.) Rod and Bar  
Pipe Material: **Clay** ☐ Pipe Lined  
Invert Depth: **10.54** (ft.) Flow Characteristics: **Slow**  
Deposits: ☐ None ☐ Mud ☒ Sludge ☒ Debris ☐ Grease  
Silt Depth: **2** (in.) Deposits Extent: **Medium**  
Infiltration: **None** Pipe Seal Cond: **Unknown**

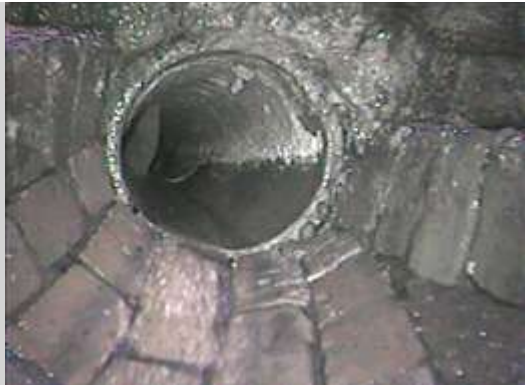
6 O'Clock Inflow

8 in. Circular Gravity Sewer

Pipe In @ 6 O'Clock

Invert Depth: **9.98** (ft.) Flow Characteristics: **Slow**

Deposits: ☒ None ☐ Mud ☐ Sludge ☐ Debris ☐ Grease

Infiltration: **None** Pipe Seal Cond: **Sound**

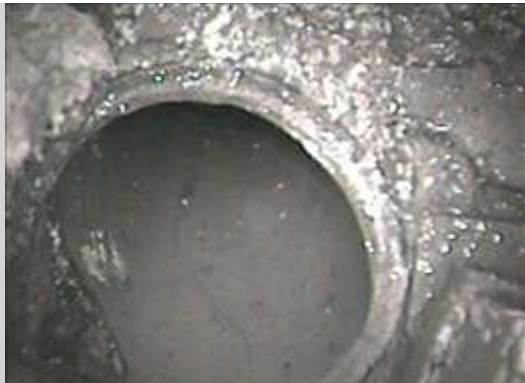
9 O'Clock Inflow

6 in. Circular Gravity Sewer

Pipe In @ 9 O'Clock

Invert Depth: **9.88** (ft.) Flow Characteristics: **Slow**

Deposits: ☒ None ☐ Mud ☐ Sludge ☐ Debris ☐ Grease

Infiltration: **None** Pipe Seal Cond: **Sound**

Connects To: **House connection / Service line**
